PALM STREET WATER PLANT CONDITION ASSESSMENT

City of Huntsville

July 31, 2015

FREESE AND NICHOLS, INC.
11200 Broadway Street
Offices West, Suite 2332
Pearland, TX 77584
832-456-4700

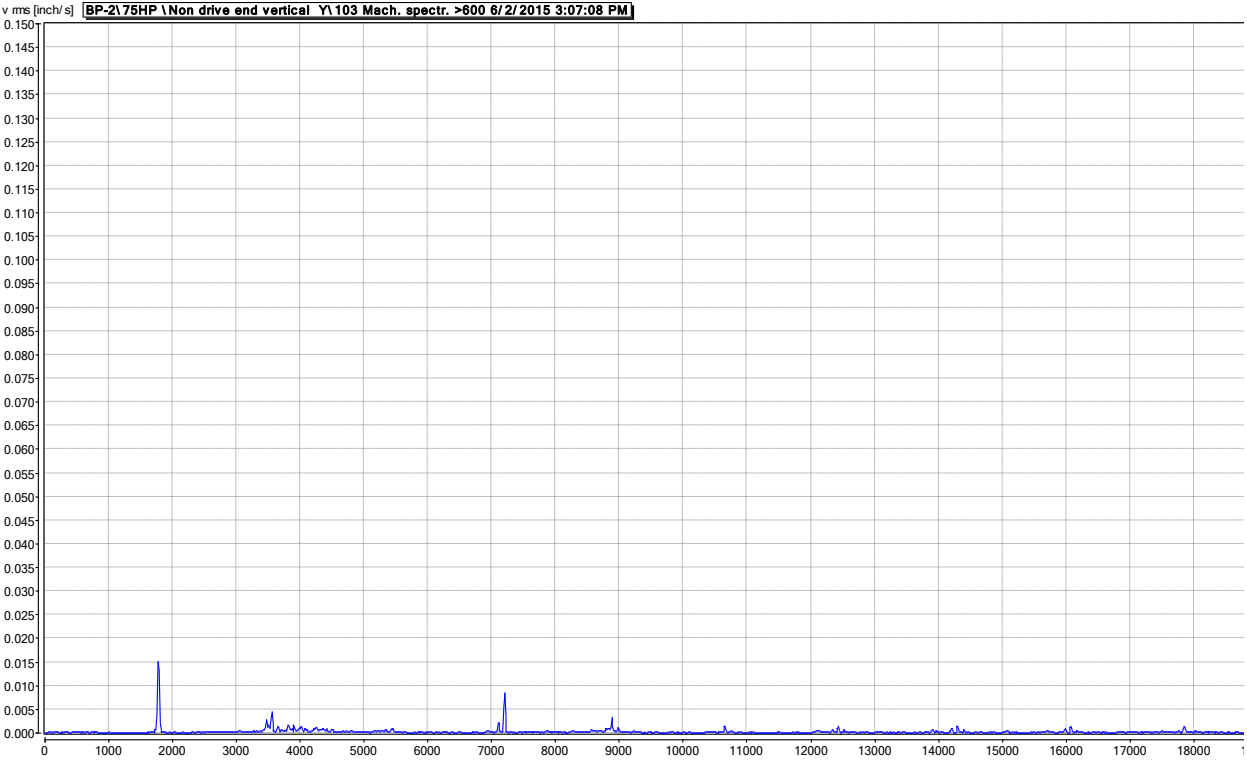
Figure 48: Motor ODE-Y Filtered Vibration, all peaks are below 0.015 in/sec

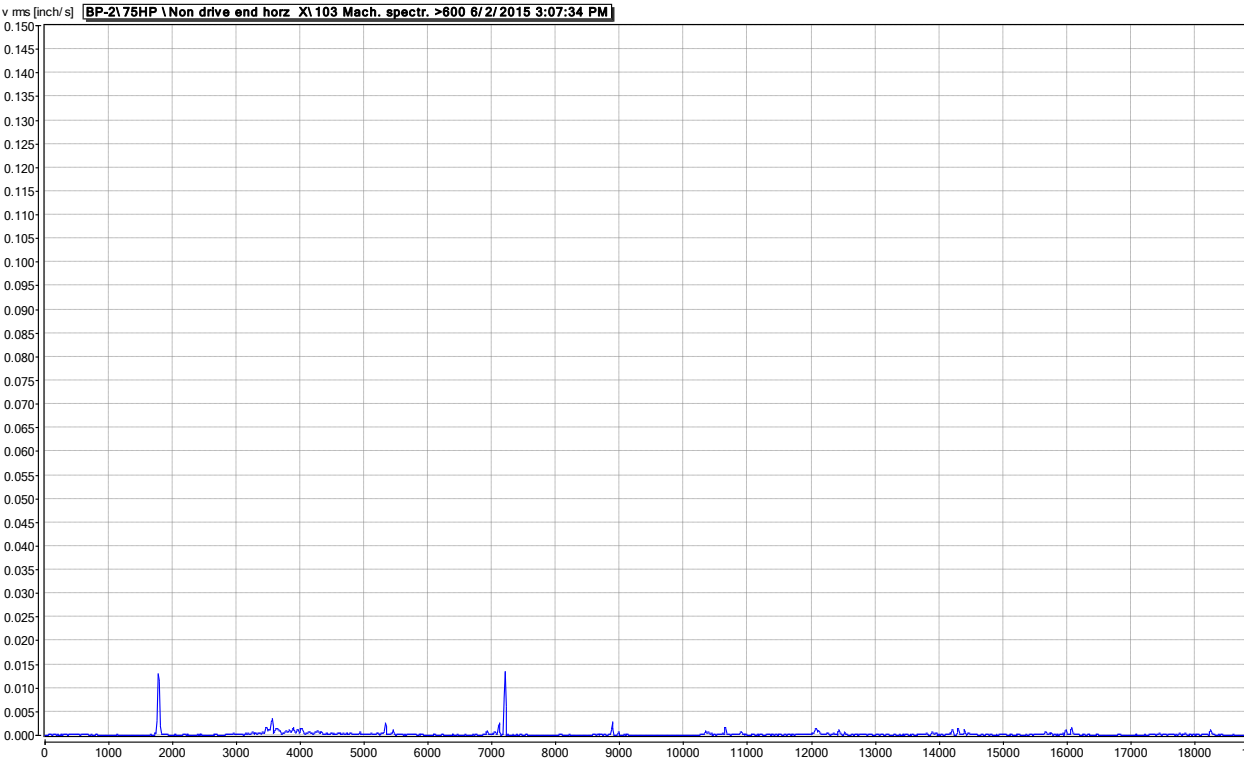
Figure 49: Motor ODE-X Filtered Vibration, all peaks are below 0.015 in/sec

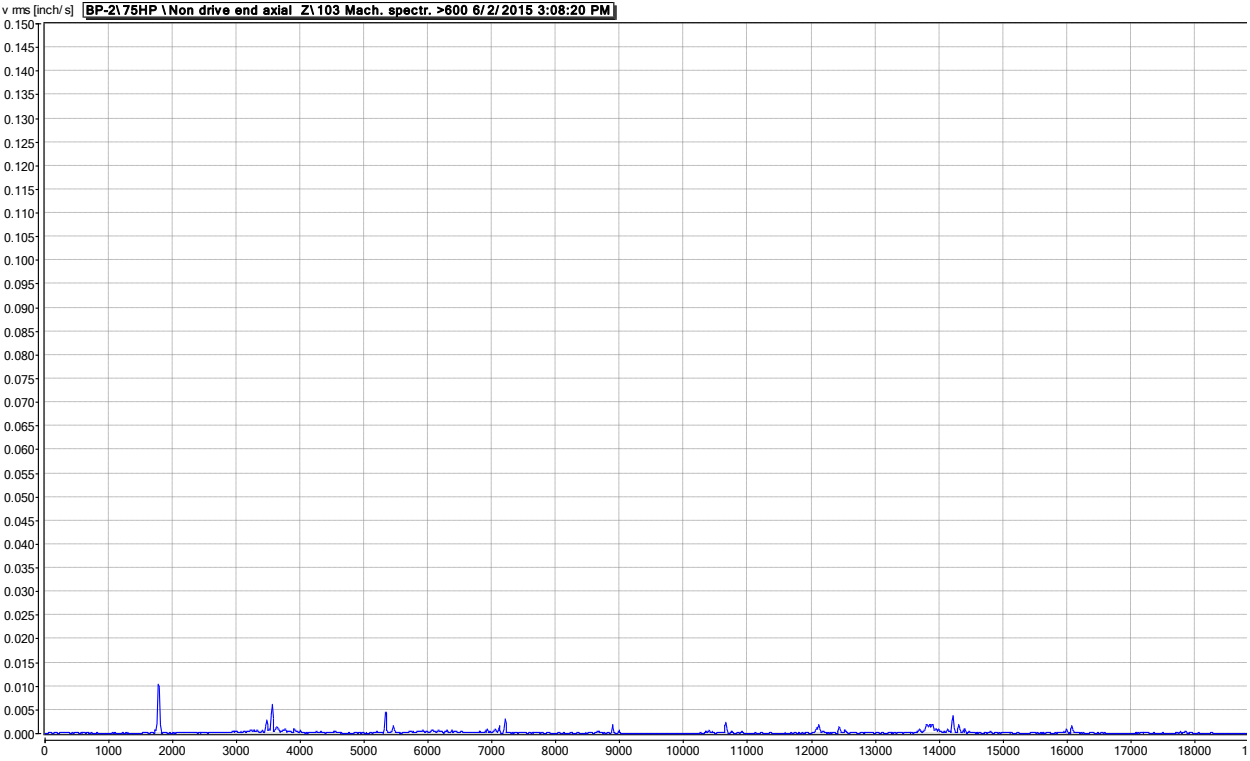
Figure 50: Motor ODE-Z Filtered Vibration, all peaks are below 0.010 in/sec

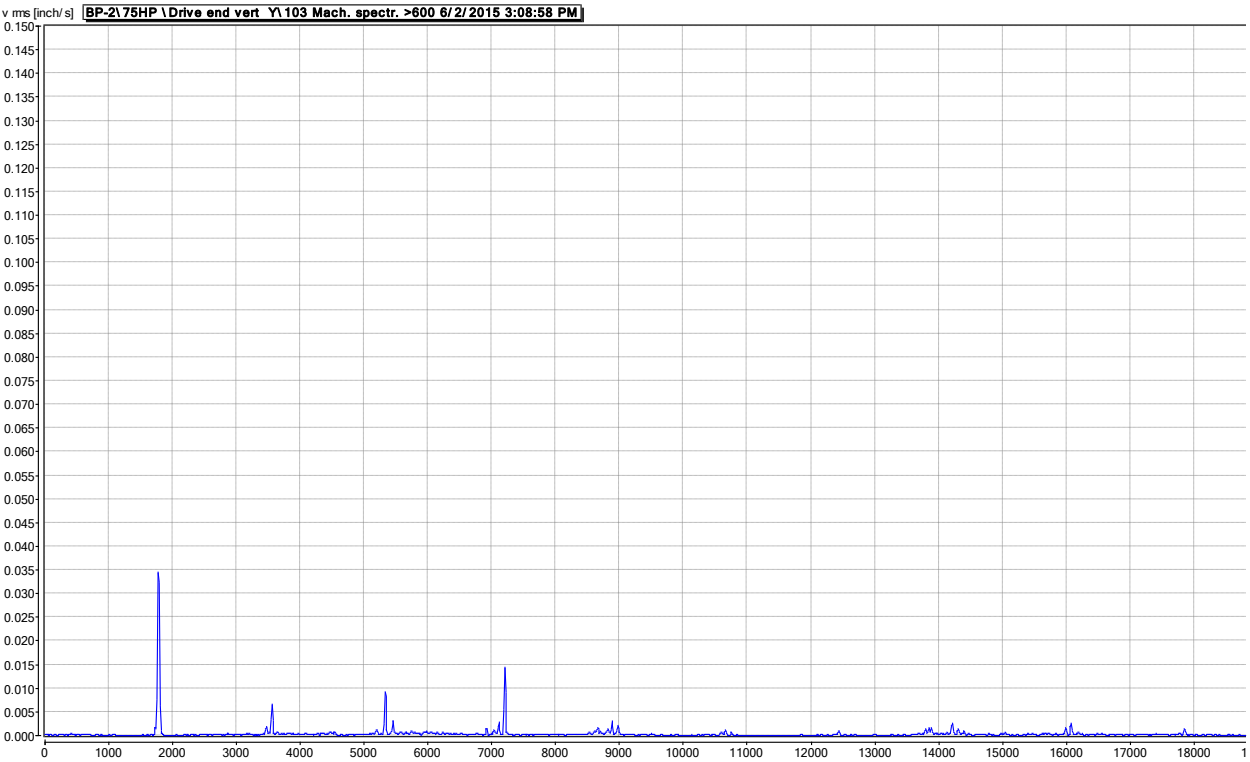
Figure 51: Motor DE-Y Filtered Vibration, highest peak is 0.034 in/sec at 1,778 cpm (1X run speed) with the remaining peaks below 0.015 in/sec

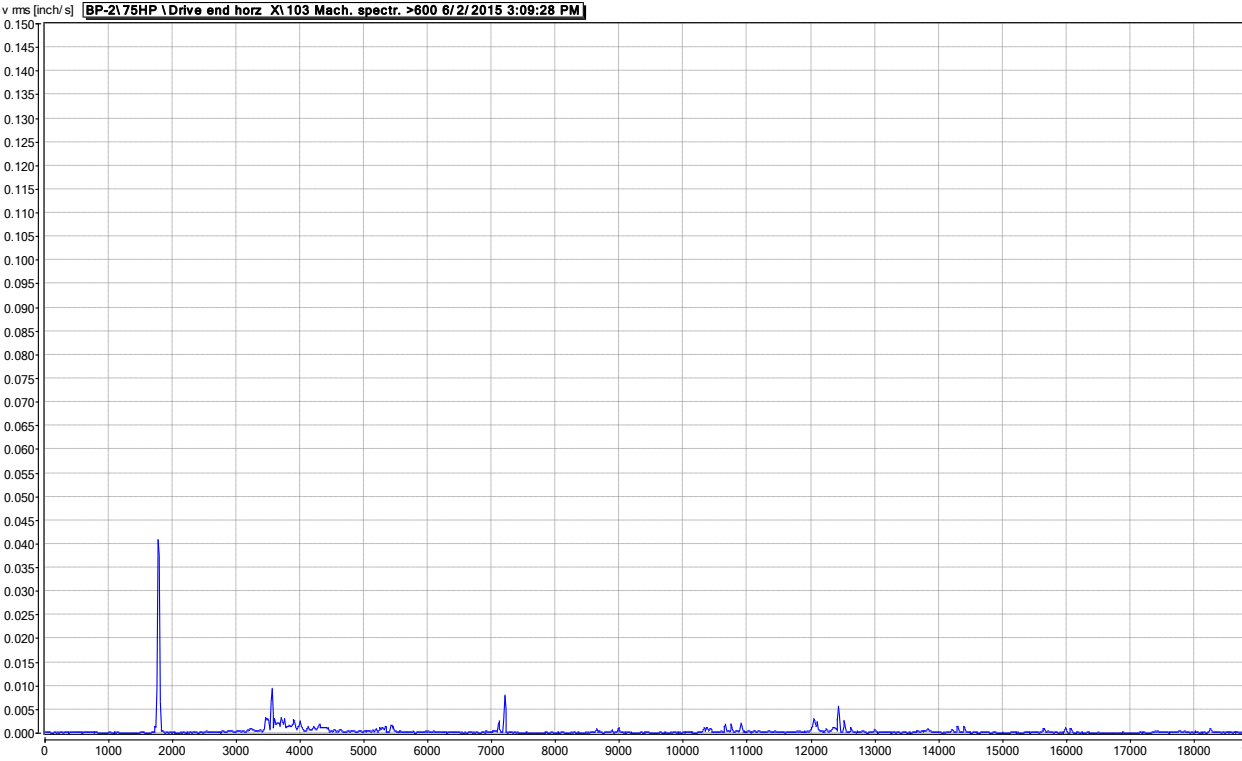
Figure 52: Motor DE-X Filtered Vibration, highest peak is 0.041 in/sec at 1,778 cpm (1X run speed) with the remaining peaks below 0.010 in/sec

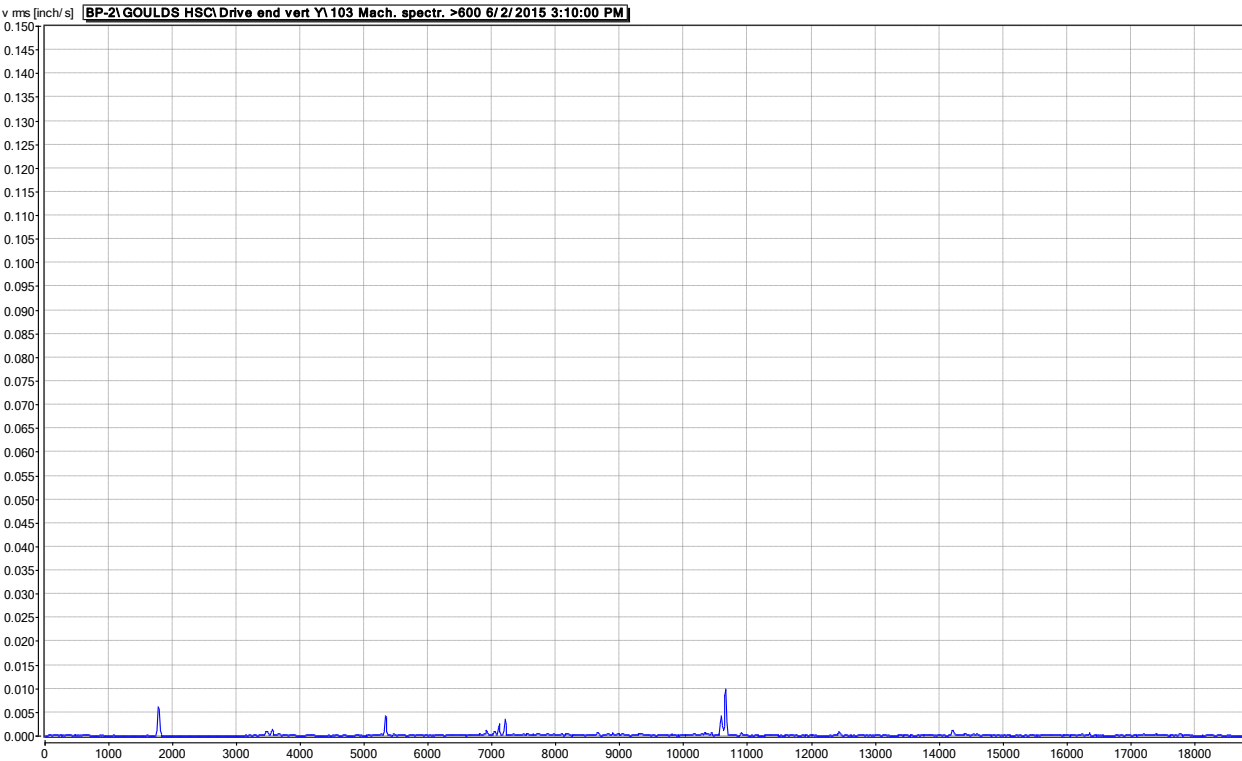
Figure 53: Pump DE-Y Filtered Vibration, all peaks are below 0.010 in/sec

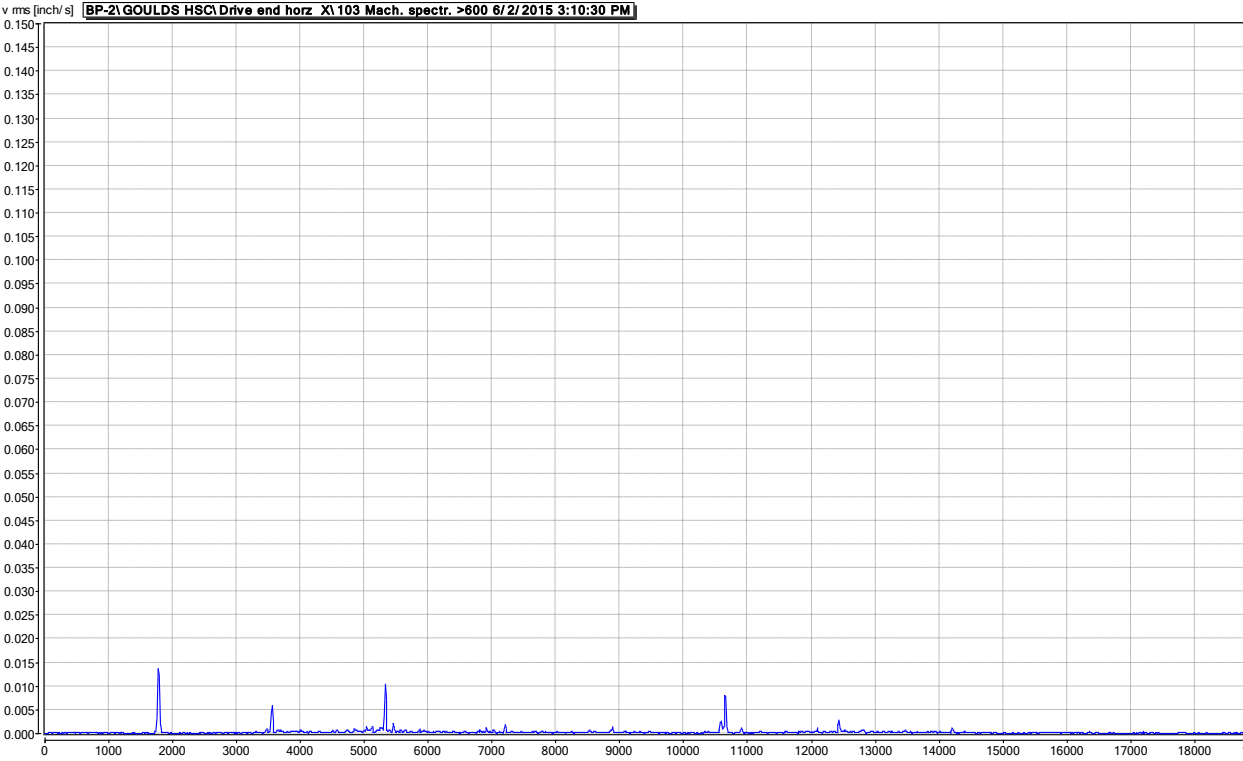
Figure 54: Pump DE-X Filtered Vibration, all peaks are below 0.010 in/sec

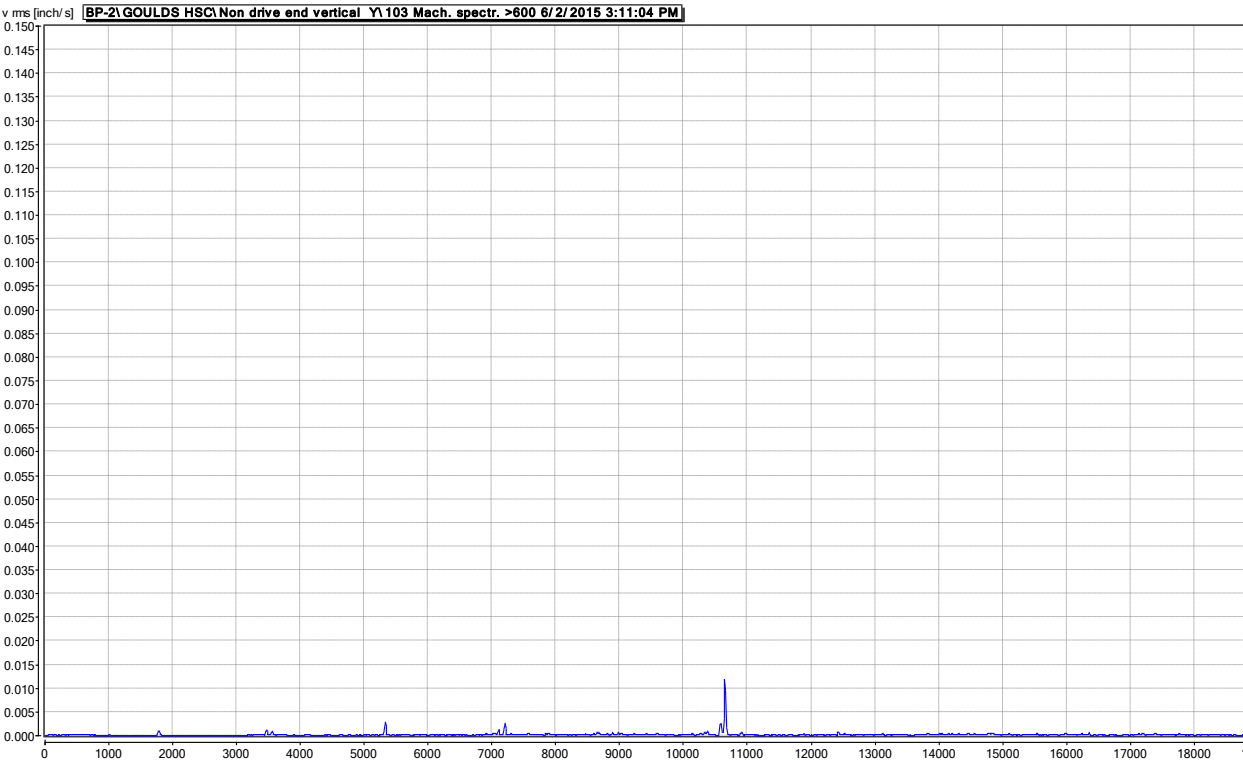
Figure 55: Pump ODE-Y Filtered Vibration, all peaks are below 0.015 in/sec

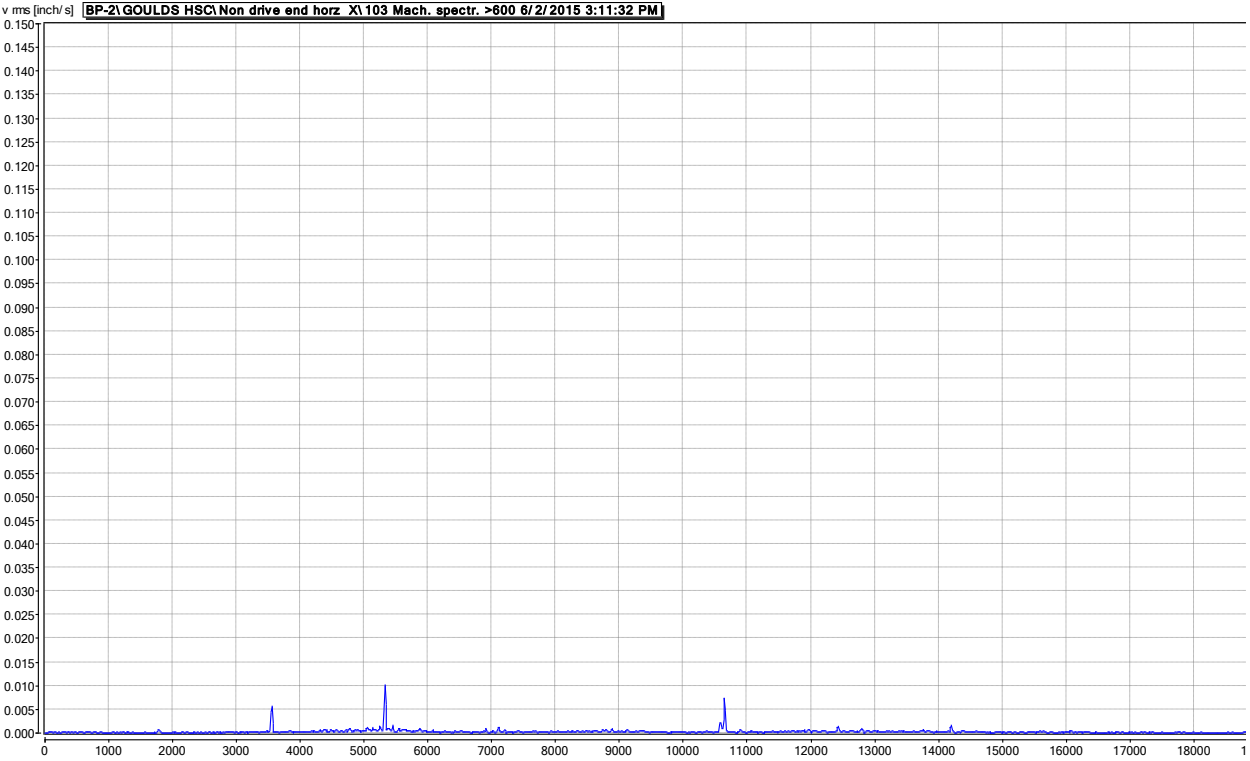
Figure 56: Pump ODE-X Filtered Vibration, all peaks are below 0.010 in/sec

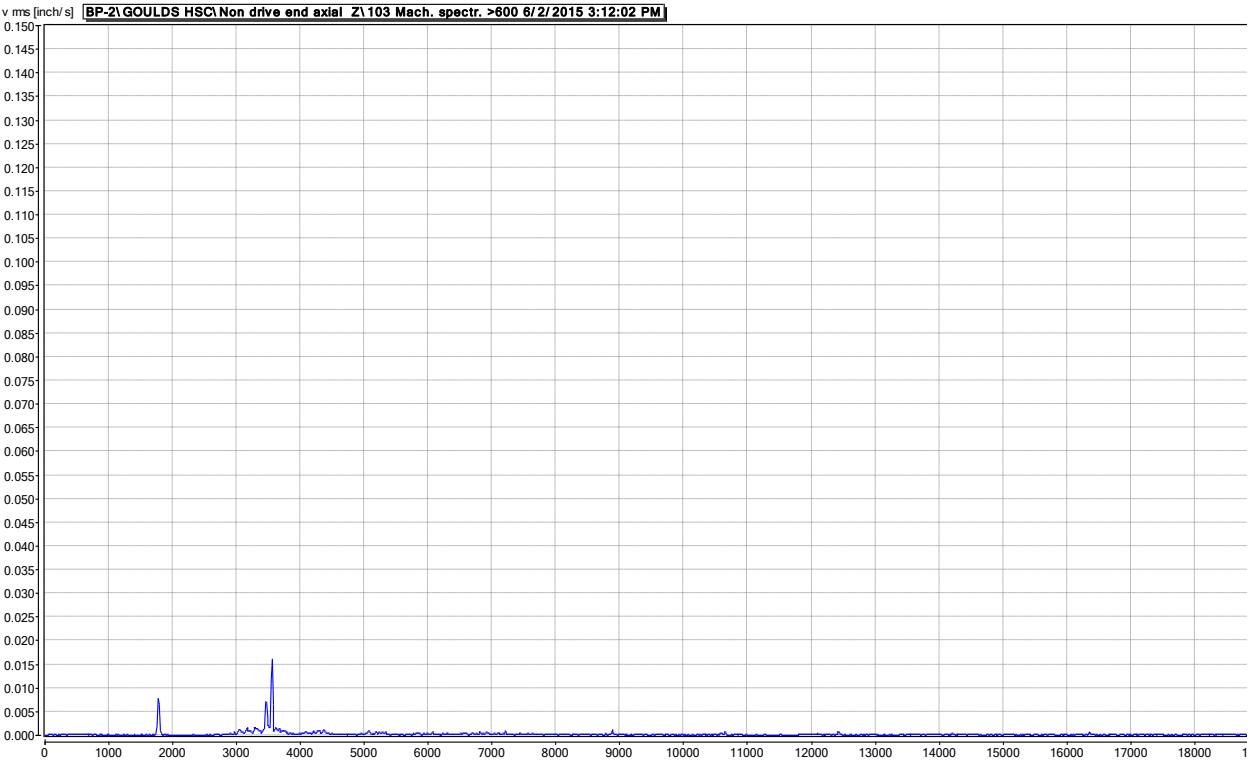
Figure 57: Pump ODE-Z Filtered Vibration, the highest peak is 0.016 in/sec at 3,551 cpm (2X run speed)

The motor and pump vibration are very low at all locations.

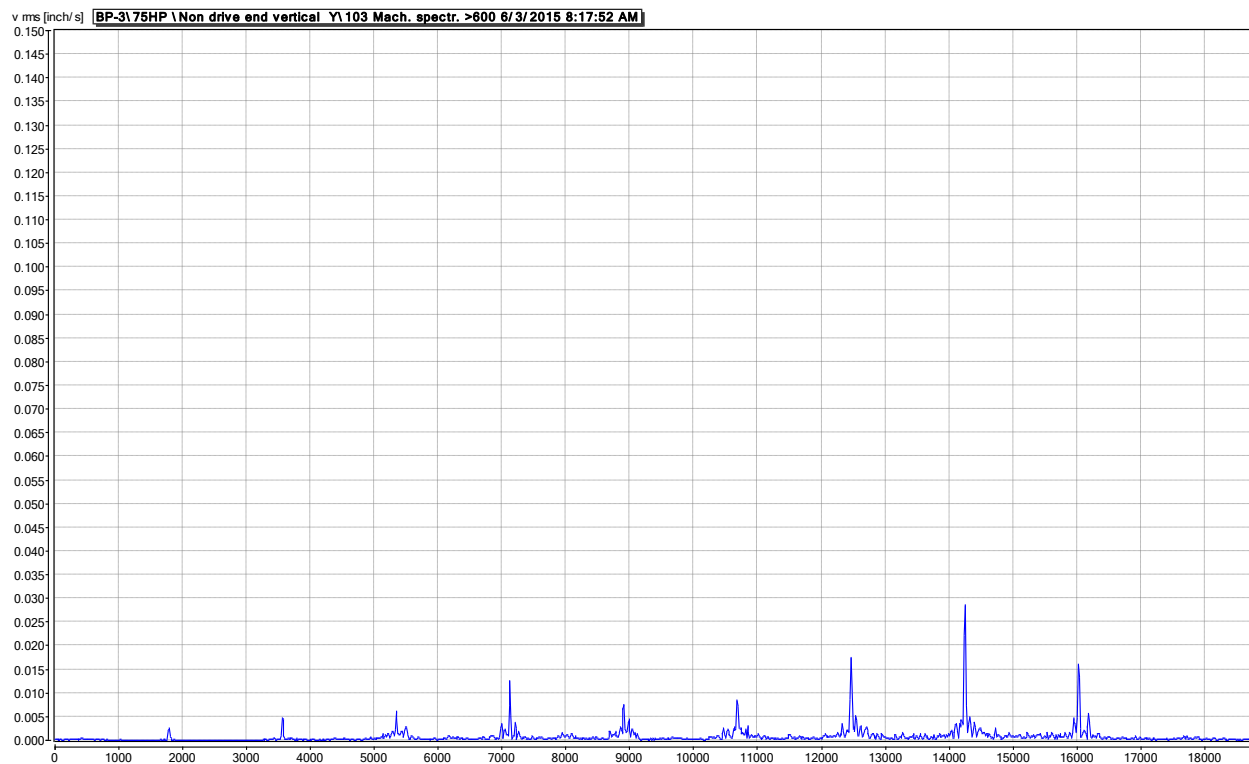
Figure 58: Motor ODE-Y Filtered Vibration, the highest peak is 0.029 in/sec at 14,246 cpm (8X run speed) with other peaks at 1X, 2X, 3X, 4X, 5X, 6X, 7X, and 9X

The motor vibration has peaks at 1X up to 12X consistently. This is an indication of looseness in the motor or bearings. The motor should be inspected soon.

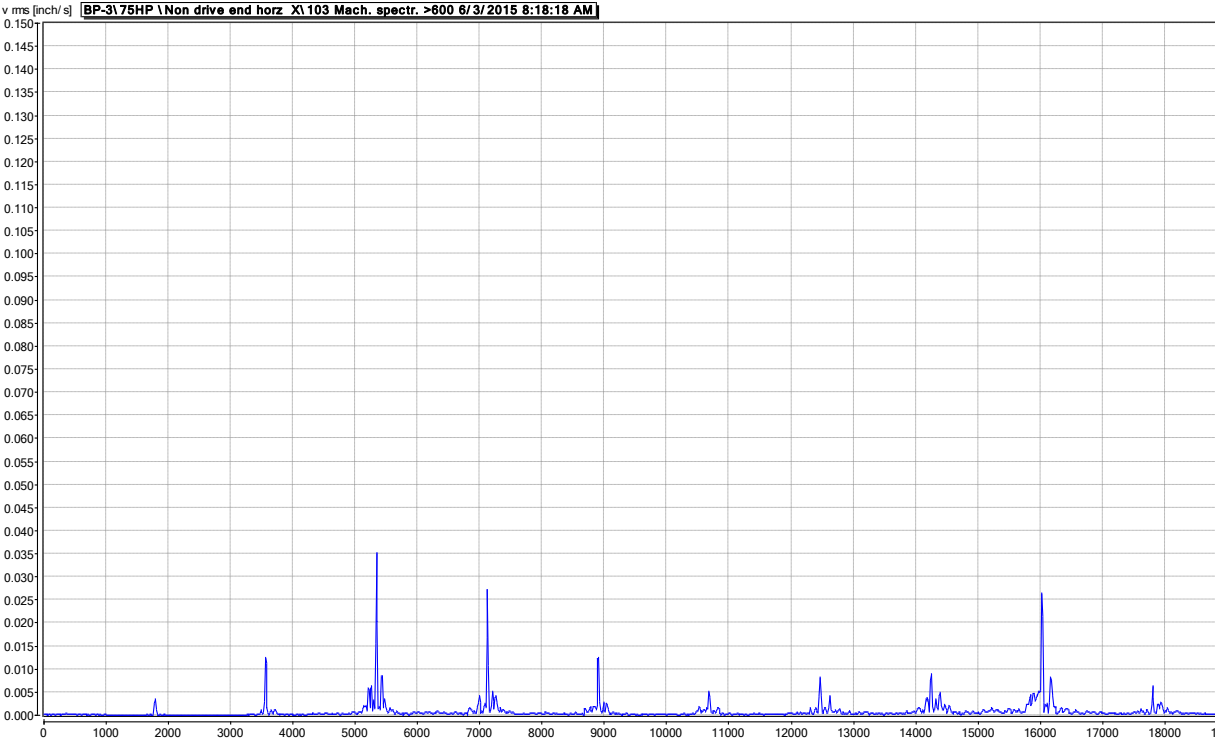
Figure 59: Motor ODE-X Filtered Vibration, the highest peak is 0.035 in/sec at 5,340 cpm (3X run speed) with other peaks at 1X, 2X, 4X, 5X, 6X, 7X, 8X, and 9X

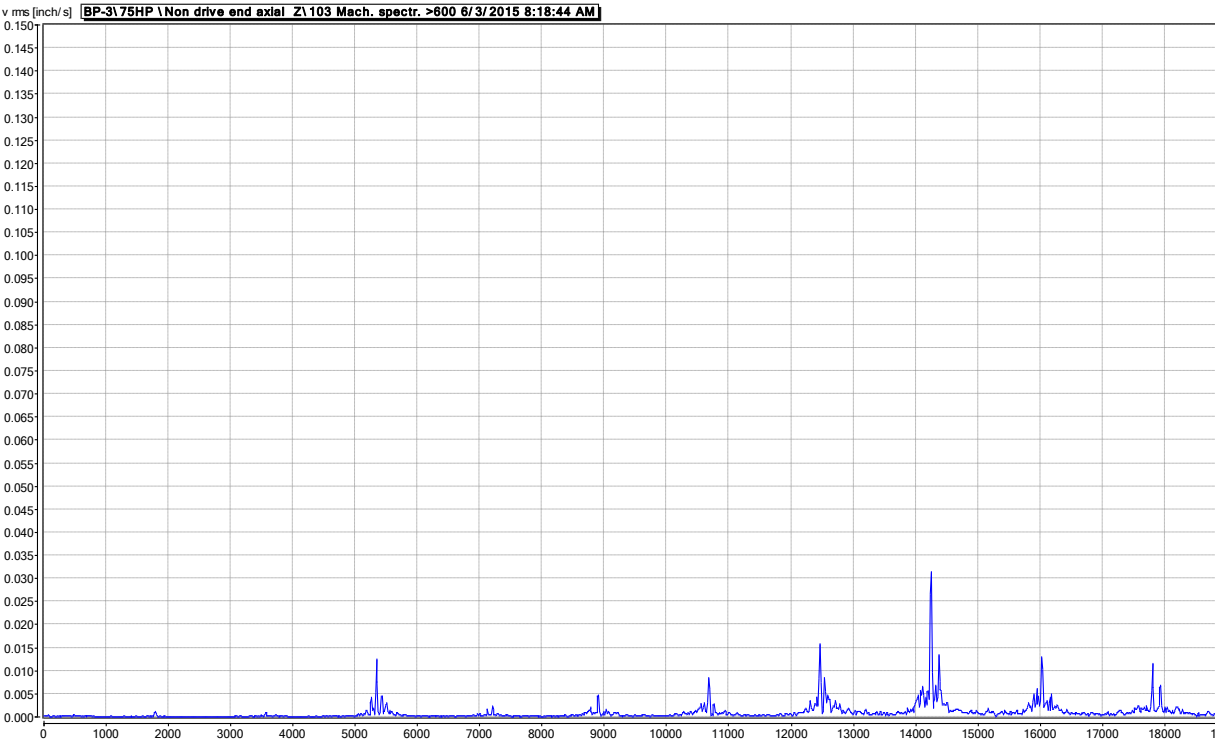
Figure 60: Motor ODE-Z Filtered Vibration, the highest peak is 0.032 in/sec at 14,242 cpm (8X run speed) with other peaks at 3X, 6X, 7X, 8X, 9X, 10X, 11X, and 12X

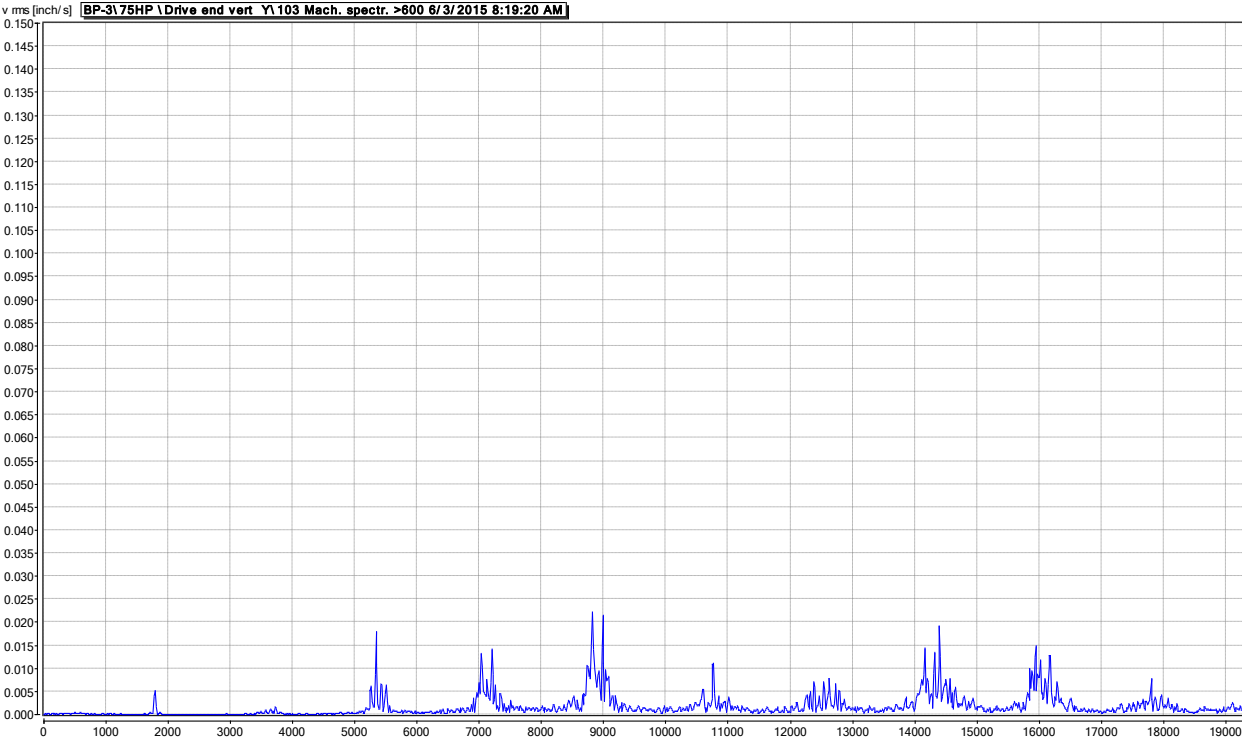
Figure 61: Motor DE-Y Filtered Vibration, highest peak is 0.022 in/sec at 8,816cpm (4.9X run speed) with other peaks at 1X, 3X, 4X, 6X, 7X, 8X, and 9X

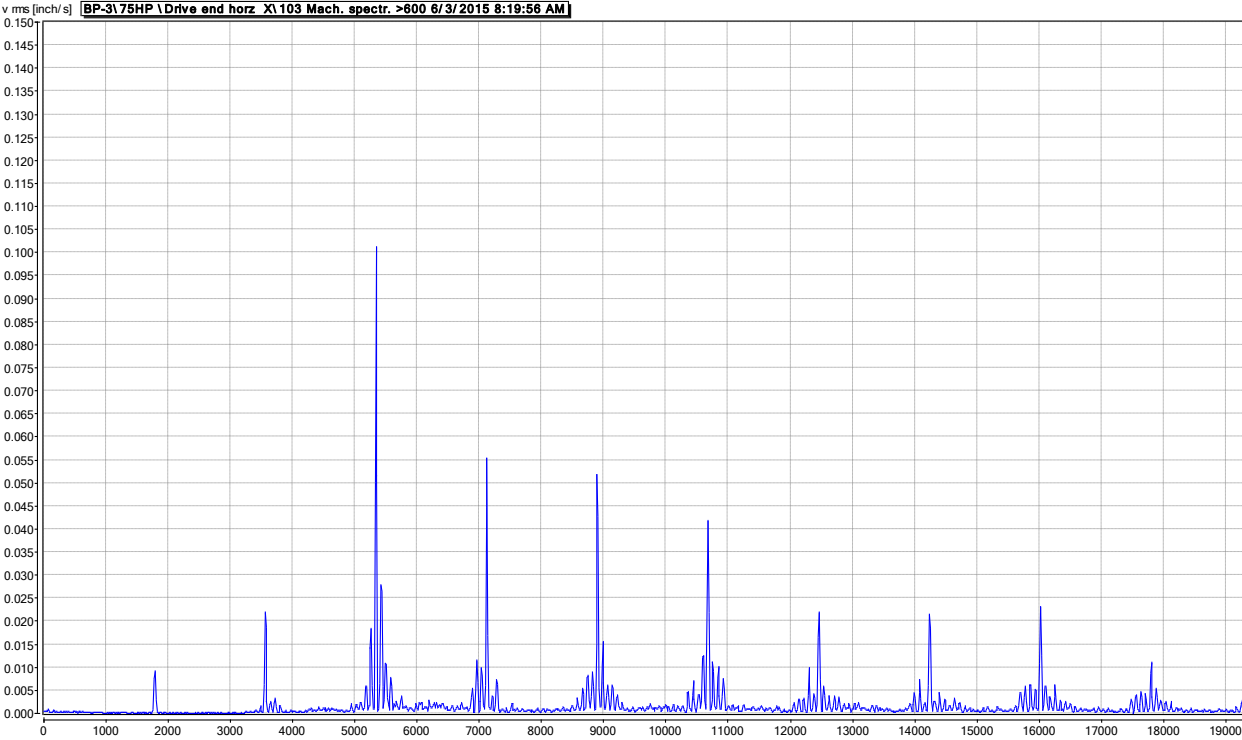
Figure 62: Motor DE-X Filtered Vibration, highest peak is 0.101 in/sec at 5,340 cpm (3X run speed) with other peaks at 1X, 2X, 4X, 5X, 6X, 7X, 8X, 9X, 10X, 11X, and 12X

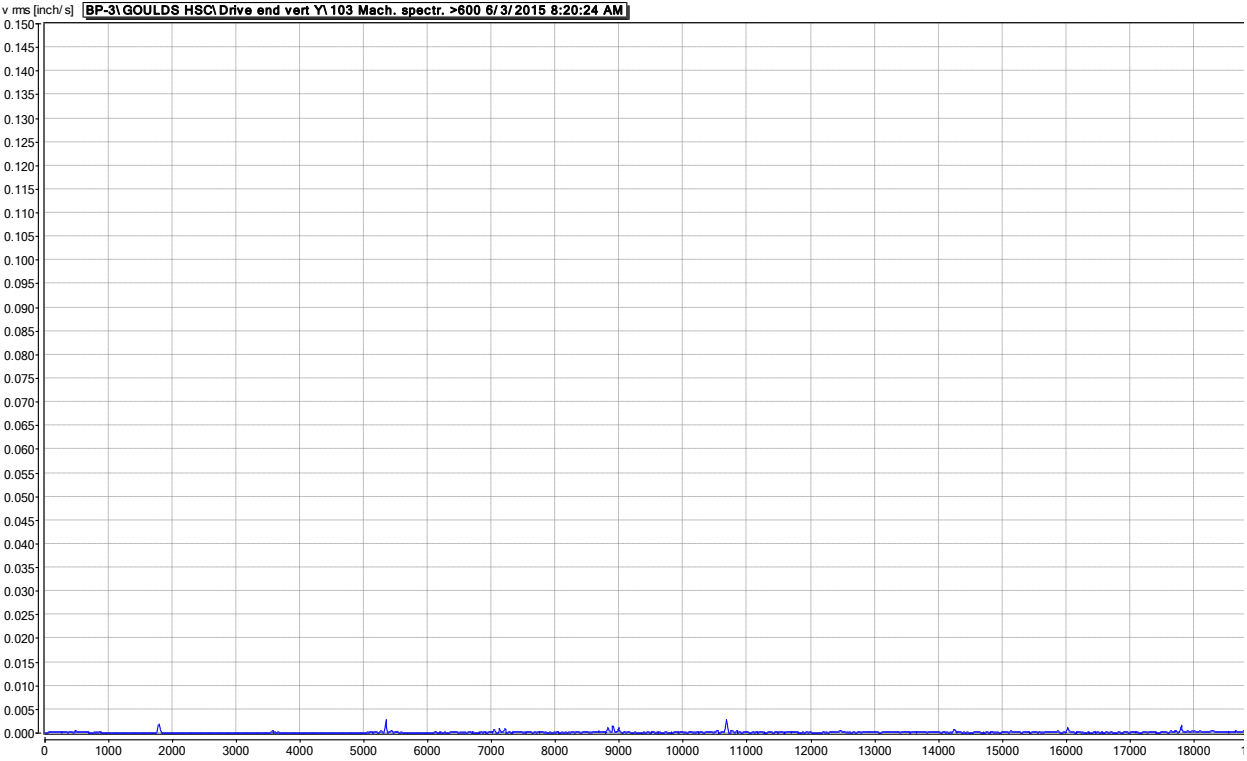
Figure 63: Pump DE-Y Filtered Vibration, all peaks are below 0.005 in/sec

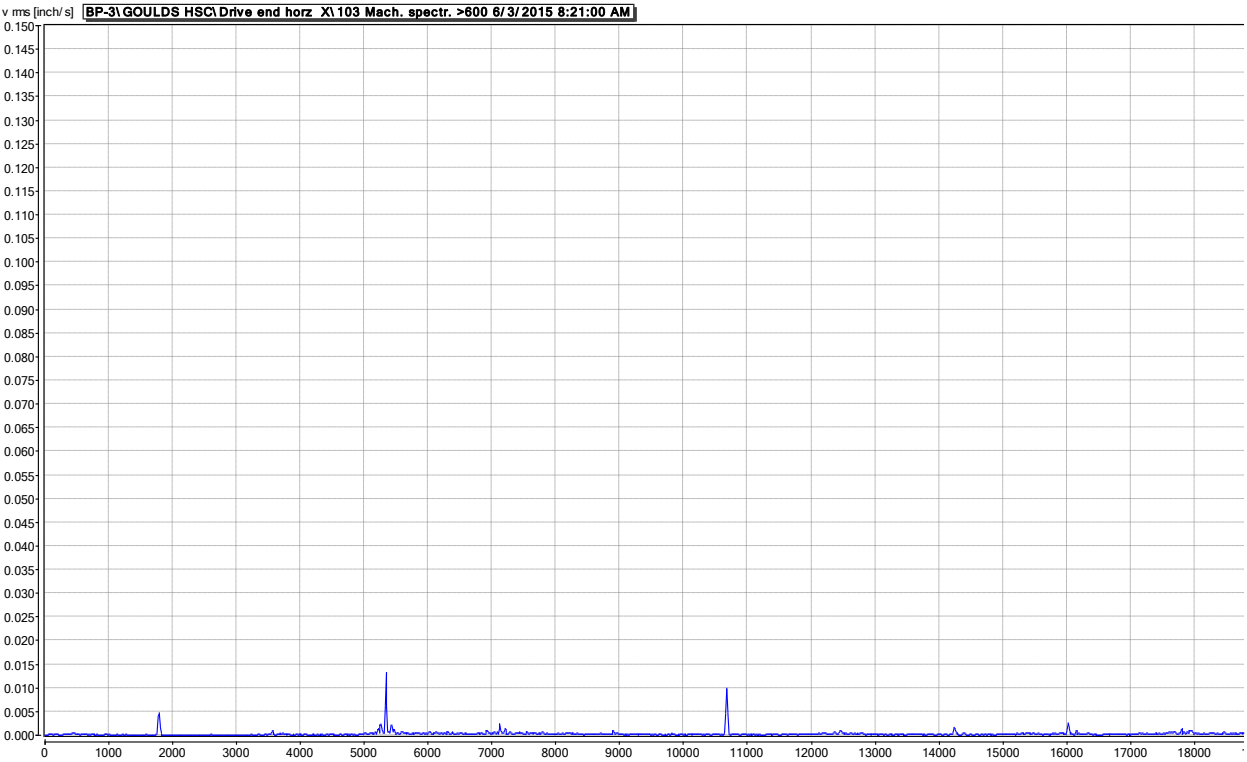
Figure 64: Pump DE-X Filtered Vibration, all peaks are below 0.015 in/sec

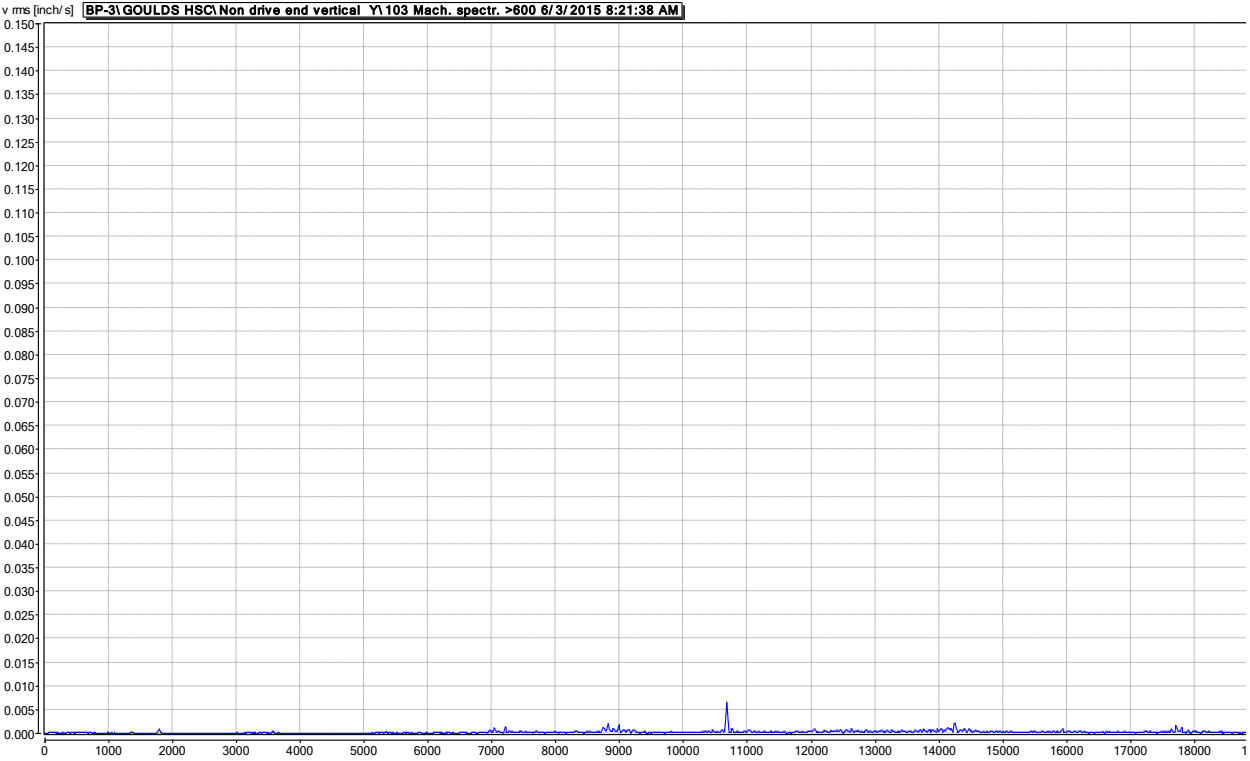
Figure 65: Pump ODE-Y Filtered Vibration, all peaks are below 0.010 in/sec

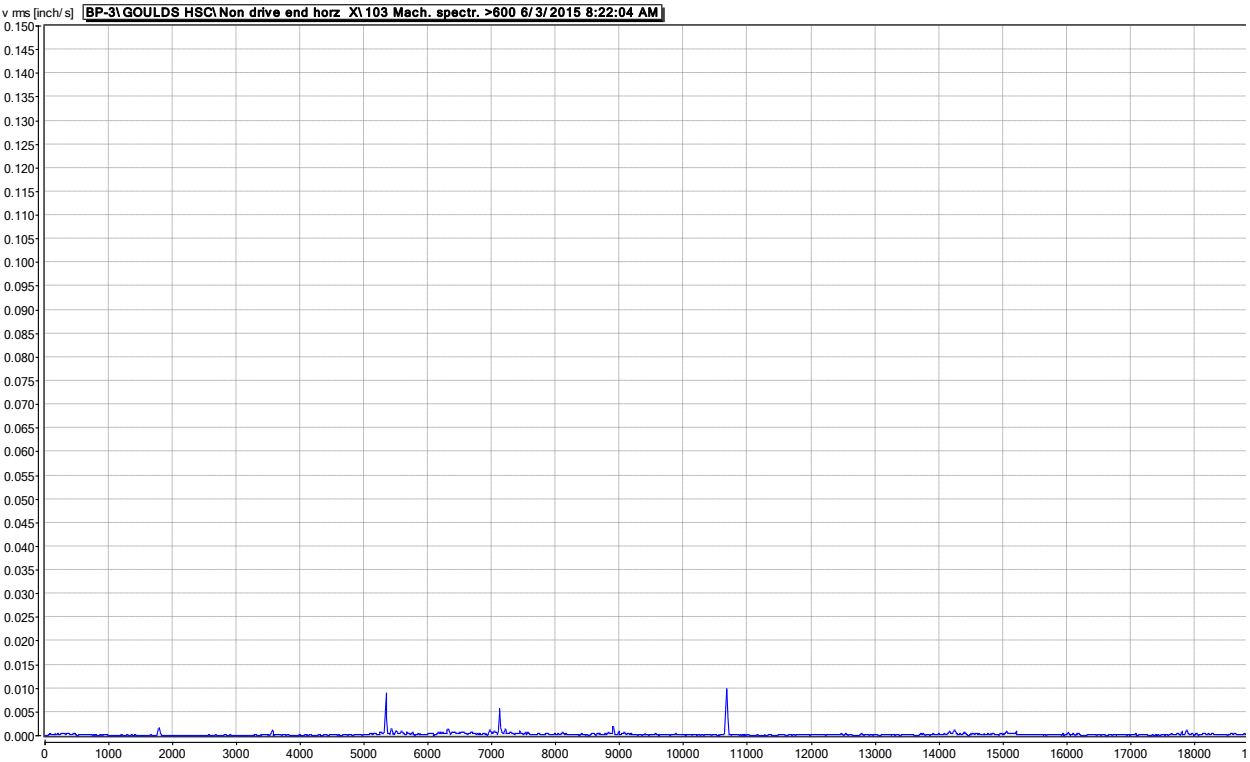
Figure 66: Pump ODE-X Filtered Vibration, all peaks are below 0.010 in/sec

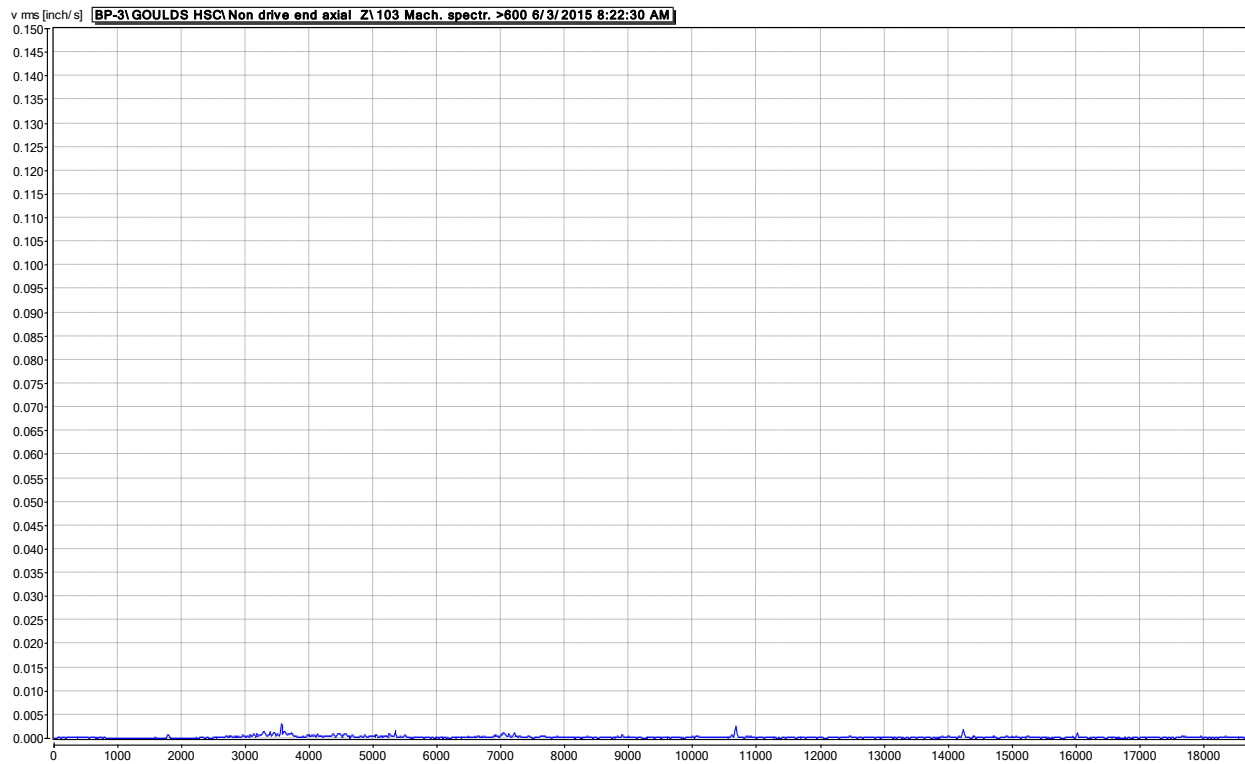
Figure 67: Pump ODE-Z Filtered Vibration, all peaks are below 0.005 in/sec

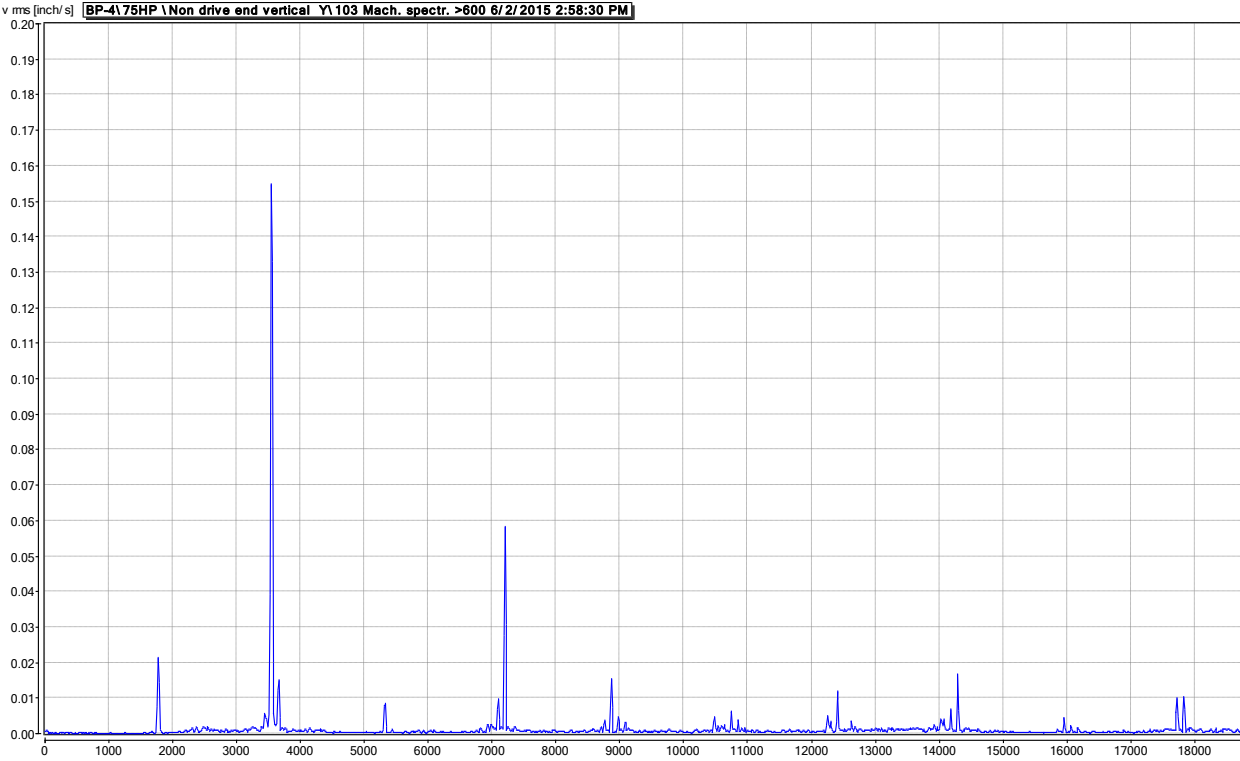
Figure 68: Motor ODE-Y Filtered Vibration, the highest peak is 0.155 in/sec at 3,548 cpm (2X run speed) with other peaks at 1X, 3X, 4X, 5X, 7X, and 8X

The motor vibration has peaks at 1X up to 7X consistently. This is an indication of looseness in the motor or bearings. The motor should be inspected soon.

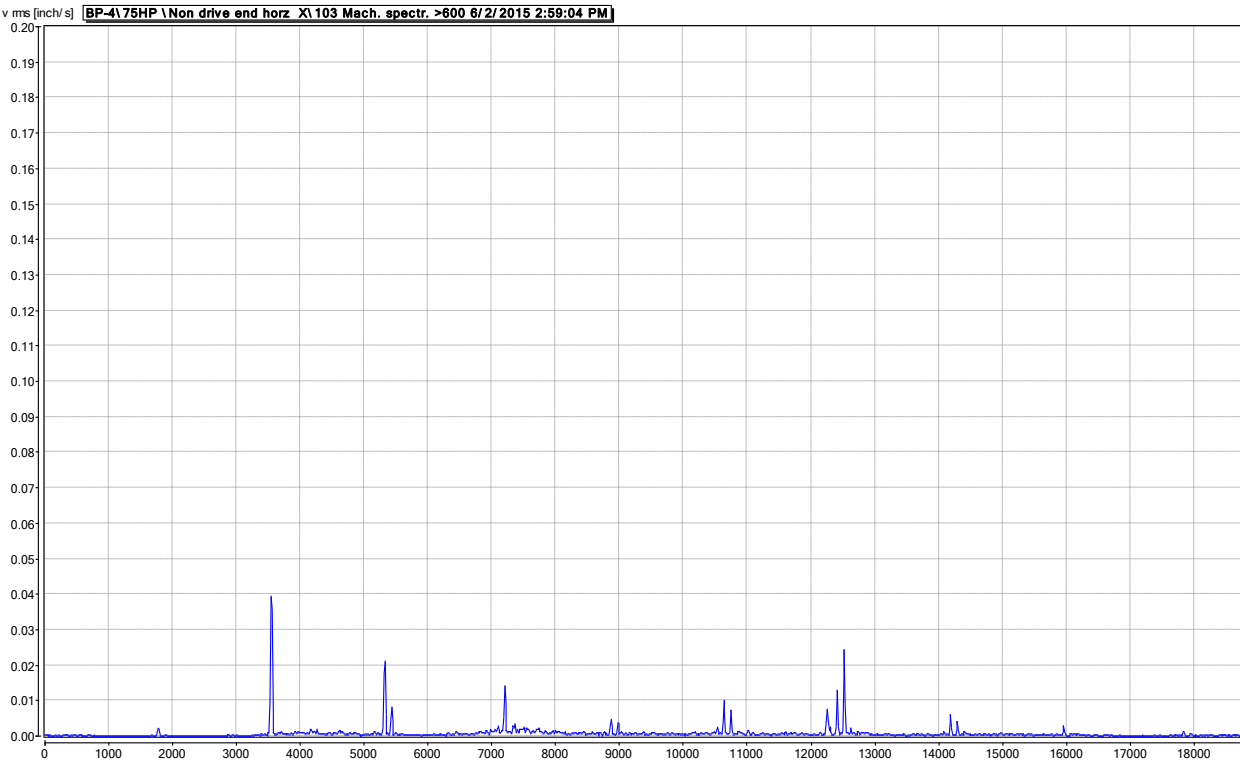
Figure 69: Motor ODE-X Filtered Vibration, the highest peak is 0.039 in/sec at 3,548 cpm (2X run speed) with other peaks at 3X, 4X, 6X, and 7X

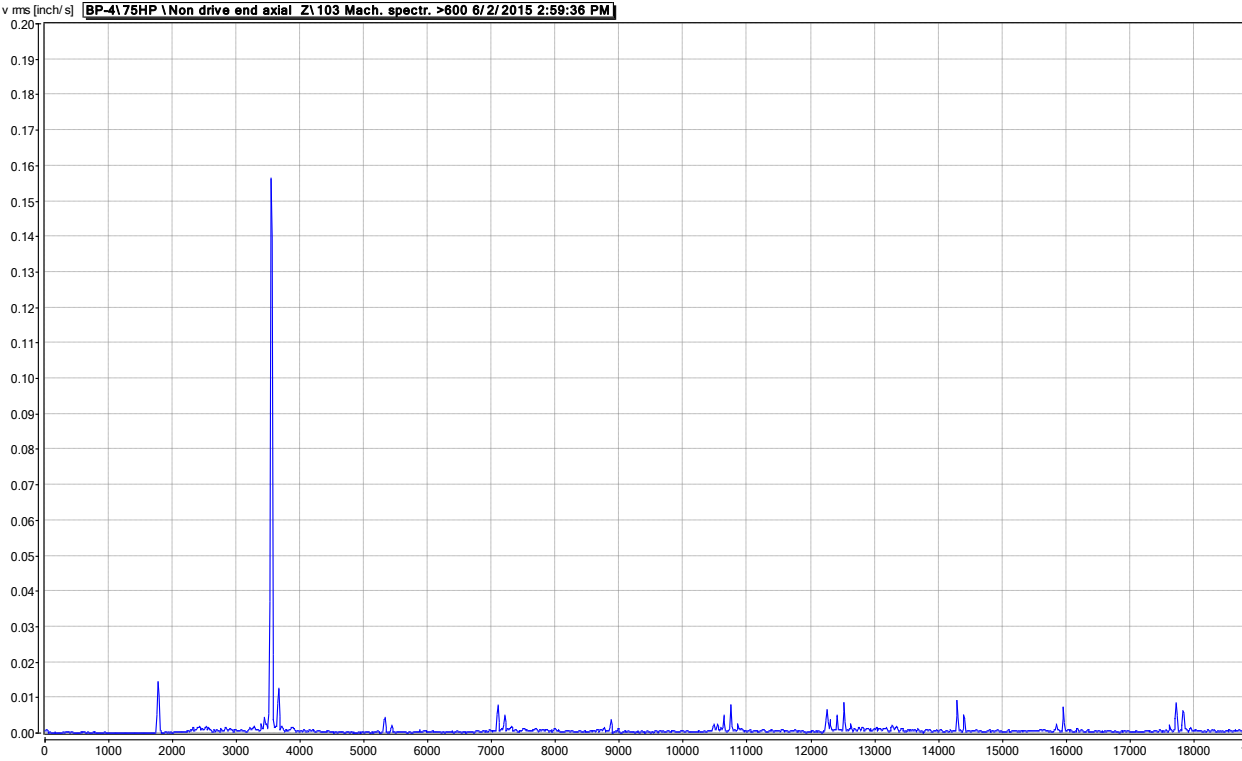
Figure 70: Motor ODE-Z Filtered Vibration, the highest peak is 0.157 in/sec at 3,548 cpm (2X run speed) with other peak at 1X
